| <b>Prüfgegenstand:</b><br><i>Test item:</i> | <b>VEHICLE PV SYSTEM</b> | | | | |
| <b>Bezeichnung / Typ-Nr.:</b><br><i>Identification / Type No.:</i> | <b>APTERA ATLAS 1</b> | | | | |

| <b>TEST REPORT</b><br><b>On-site witnessing service</b> | |

Aptera Motors requested that TÜV Rheinland provide an on-site witnessing service at Aptera's facility in Carlsbad, California. The scope of the engagement was to witness and independently verify that the Aptera solar electric vehicle, parked in direct sunlight under ambient outdoor conditions, accumulated a minimum of 4.0 kWh of usable energy delivered to the high-voltage battery pack over the course of a single calendar day.

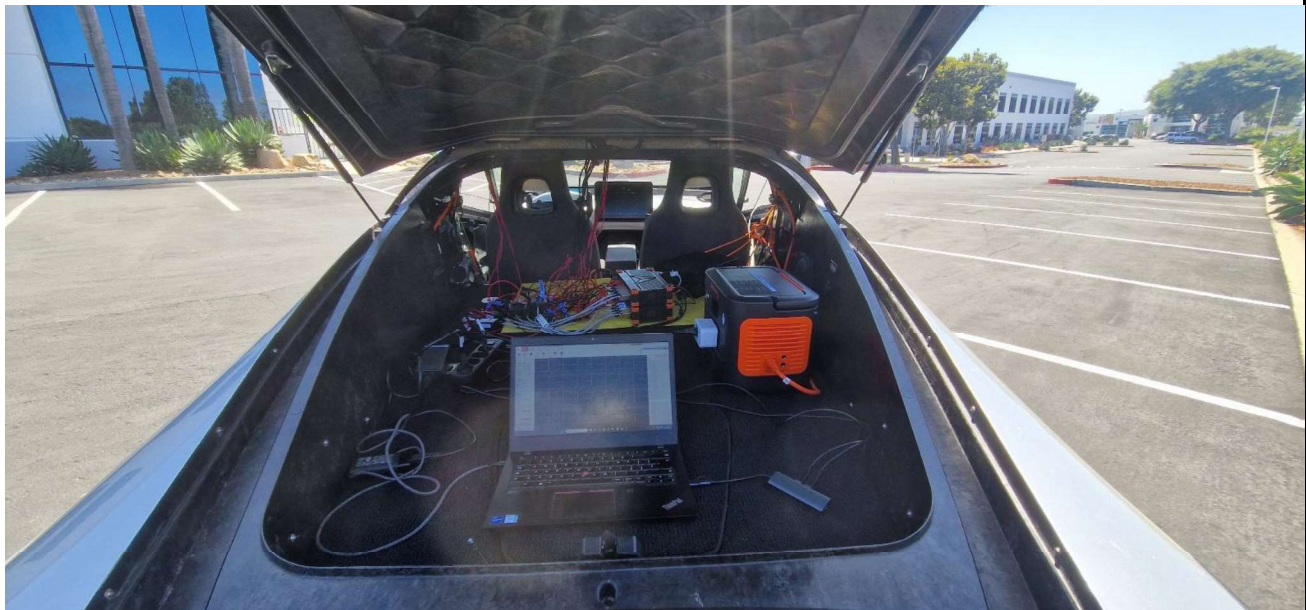
A picture of the instruments as positioned in the vehicle during one day of acquisition is shown in Figure 4.

Figure 4 Picture of the setup

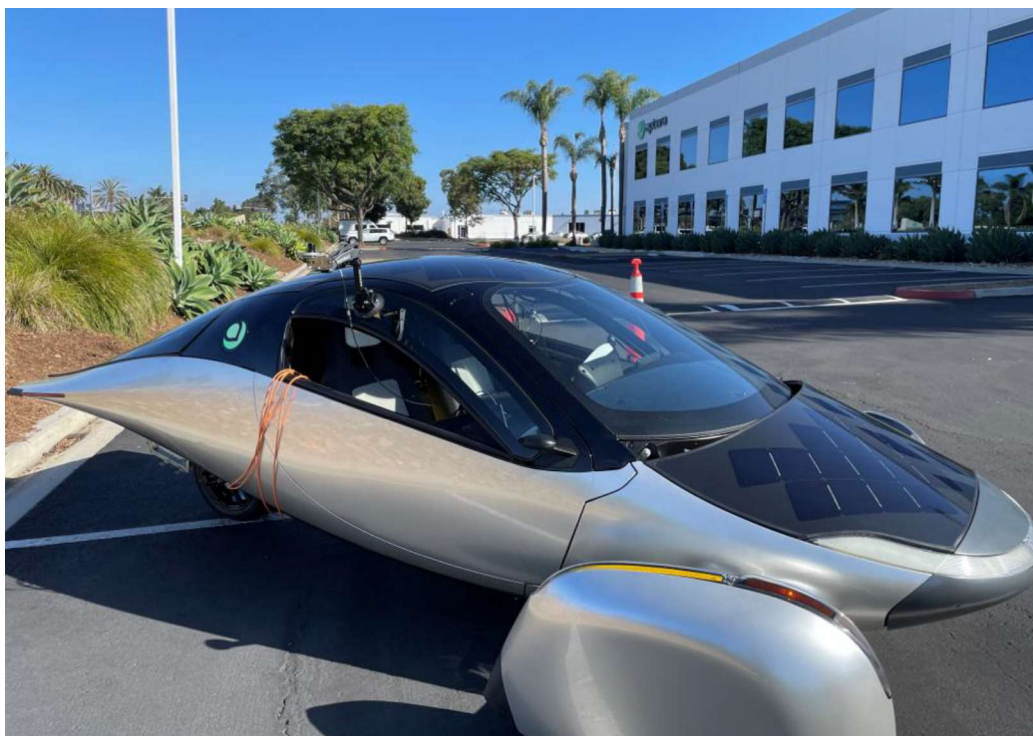
| <b>Vehicle position</b> | Fixed position 33° 8' 8" N, 117° 16' 18" W |
| <b>Vehicle orientation</b> | Fixed orientation: Front facing 84° East |
| <b>Vehicle condition</b> | Vehicle kept in fixed position and orientation with HATCH always closed during the entire testing time. |
| <b>Testing period</b> | From 7:03 AM to 7:07 PM |

Figure 5 – testing conditions of Day 1: July 6th 2026

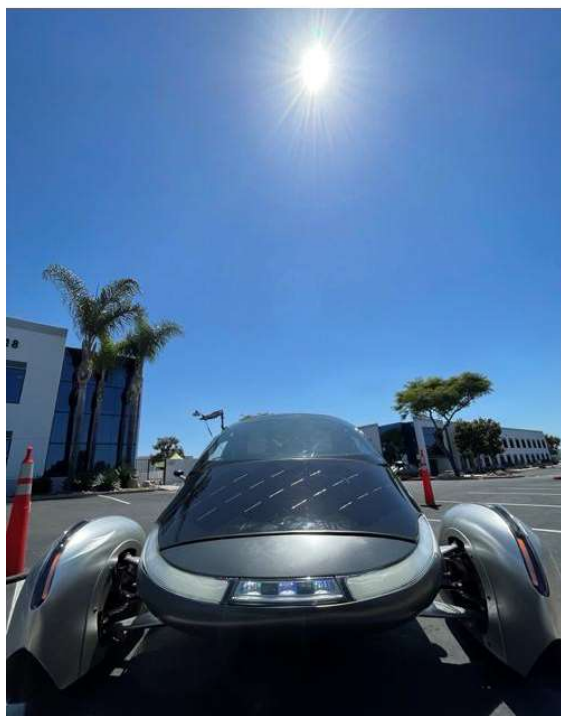
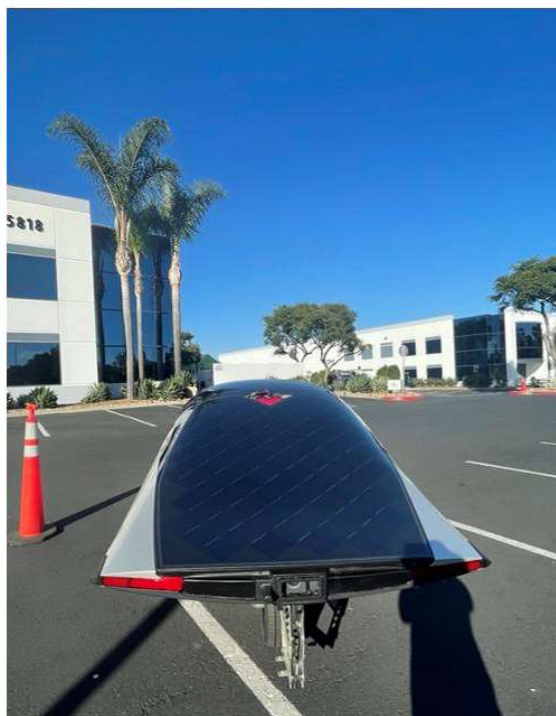
| <b>Vehicle orientation</b> | <ul style="list-style-type: none"> <li>Rear facing 90° East (morning 7:32 am – 1 pm)</li> <li>Front facing 90° East (afternoon 1 pm – 7:03 pm)</li> </ul> |
| <b>Vehicle condition</b> | Vehicle kept in fixed position but orientation changed once during the day. HATCH always closed during the entire testing time. |

Figure 11 – Testing conditions of DAY 2: July 7th 2026
